# **Village of Afton Strategic Plan**

## **Task 7: Feasibility and Planning Study for Waterfront Revitalization**

Created by: GeoEco Design  
Stephanie M. Nick, MPS  
Richard Ross Shaker, MSc, PhD

May 2018

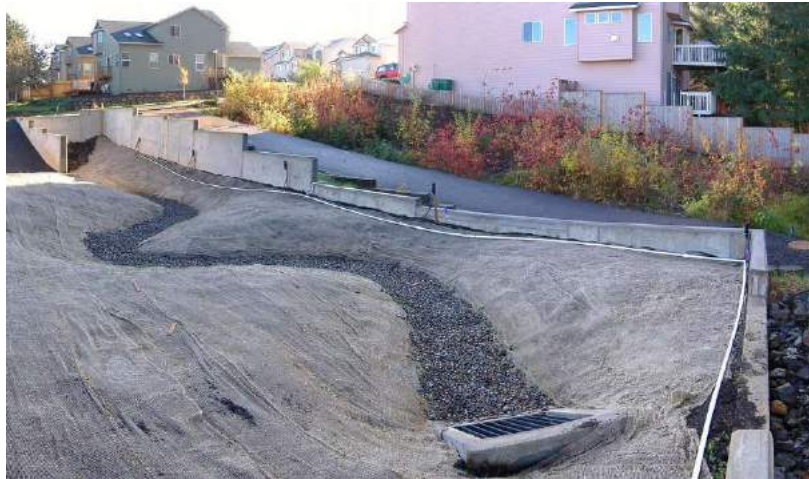
**Bioswales:** Bioswales are landscape design features built to direct and filter the flow of water such as runoff, stormwater, and floodwaters. A bioswale is also planted with vegetation which helps to filter and absorb water along the way. The picture below shows a bioswale in the foreground which is being built and a completed bioswale on the opposite side of the road.

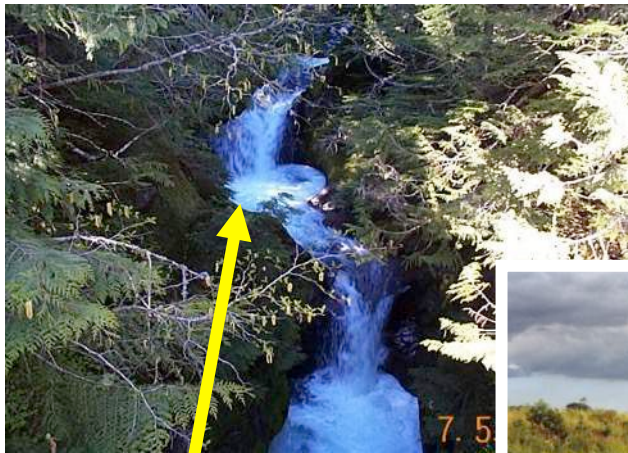
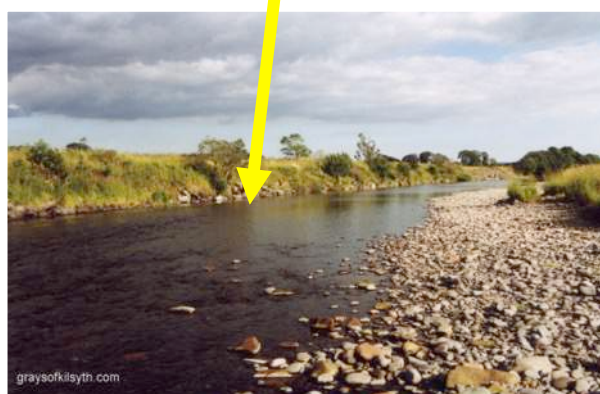
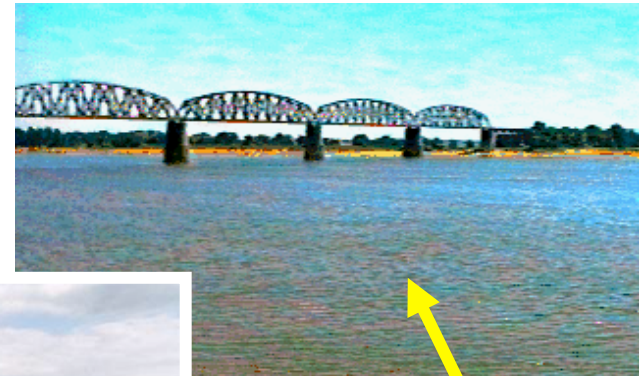
- All land on earth is a watershed.
- A watershed is often called a drainage basin.
- It is the land area drained by a network of channels, called tributaries, that increase in size as the amount of water and materials they must carry increases.

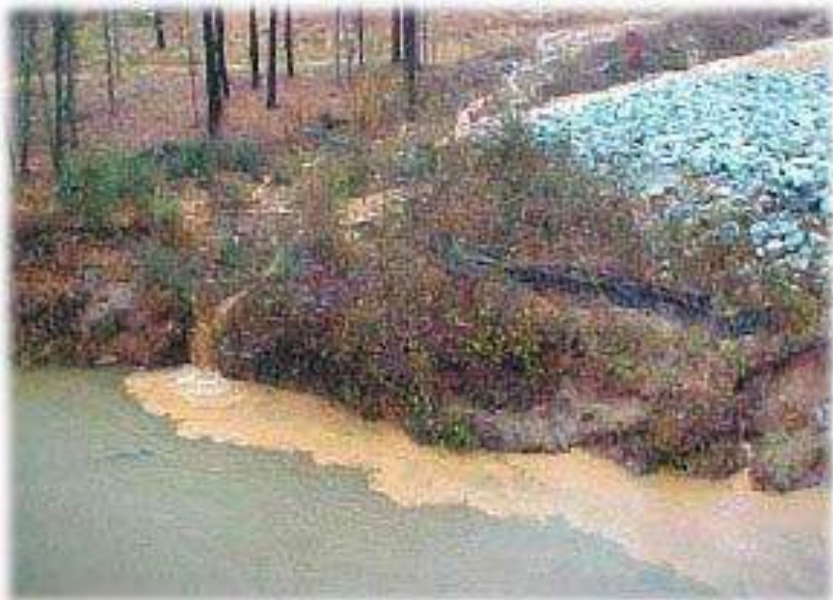
Overland runoff from disturbed areas often contains excessive sediment in addition to water. (USGS)

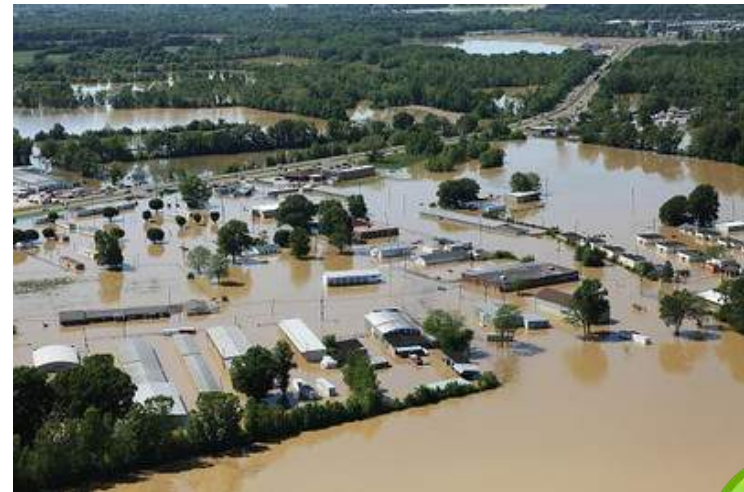
Image: Mississippi River Flood -2011

- Flash floods often contribute to downstream floods.
- **Downstream floods** are floods:
  - That cover wide areas
  - Found in low slope areas
  - Usually produced by storms of long duration that saturate soil and produce increased runoff
- Downstream floods are characterized by the downstream movement of the floodwaters with a large rise and fall of discharge at a particular location (ARS 1969).

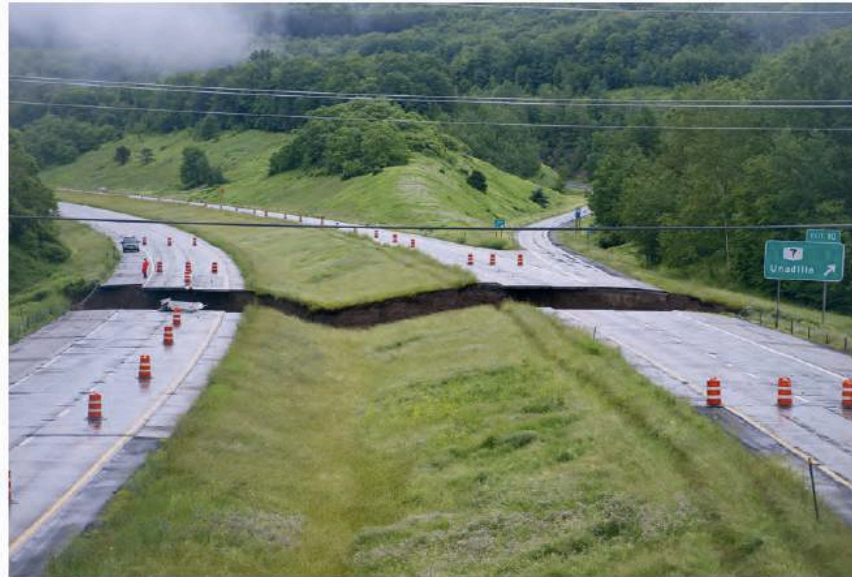
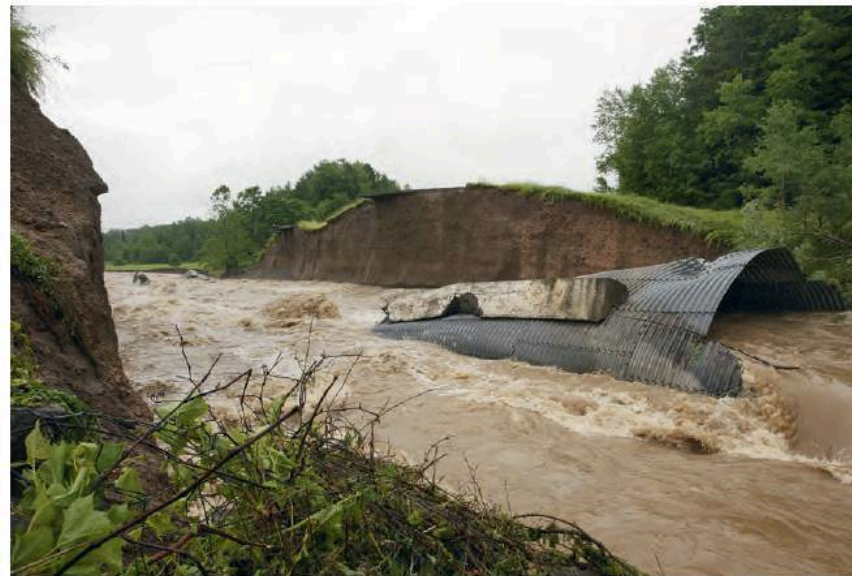
**Figure 14A.** Top—Collapse of Interstate Route 88 over Carrs Creek near Unadilla (Exit 10), NY, on June 28, 2006. Bottom—Carrs Creek and washed-out culvert at Interstate Route 88 near Unadilla (exit 10), NY, on June 28, 2006. Photos courtesy of The Daily Star, taken by staff photographer Julie Lewis.

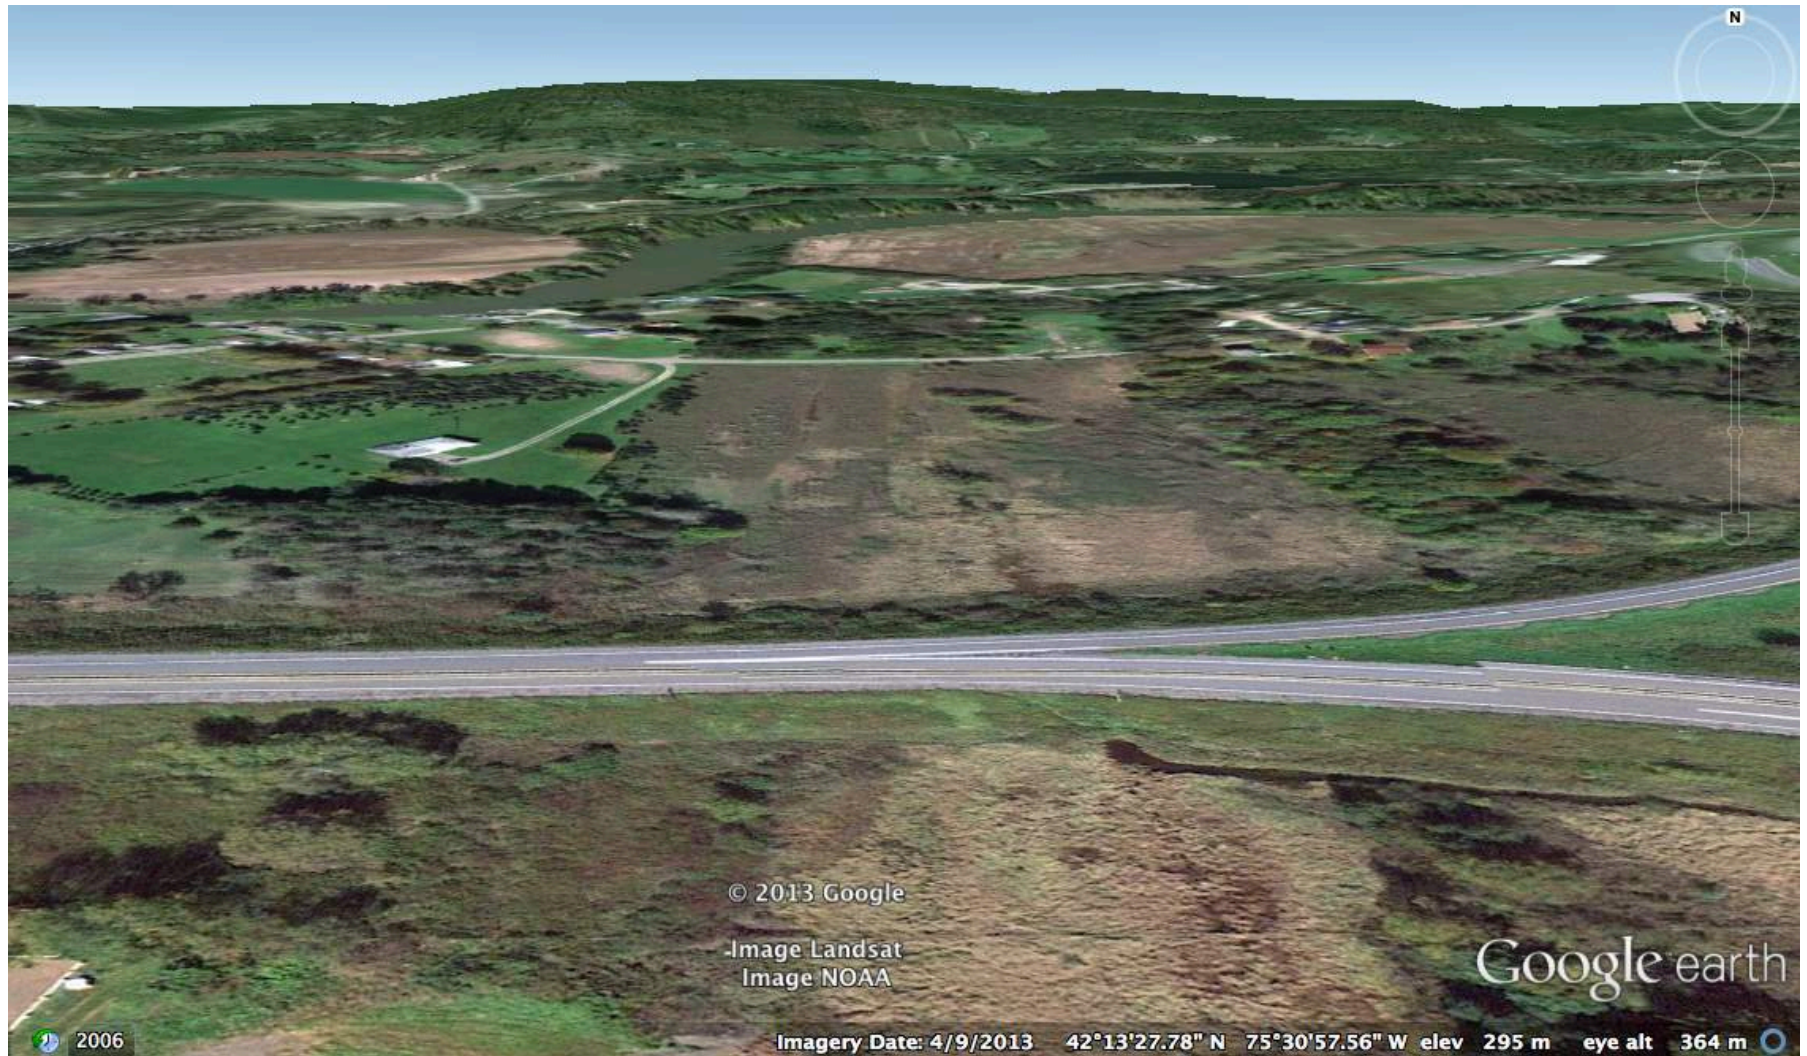
**NFIP** **PANEL 0582E**

High water mark of 2011  
was 8.9 ft above 100 Flood  
level of 2010 FIRM Map.

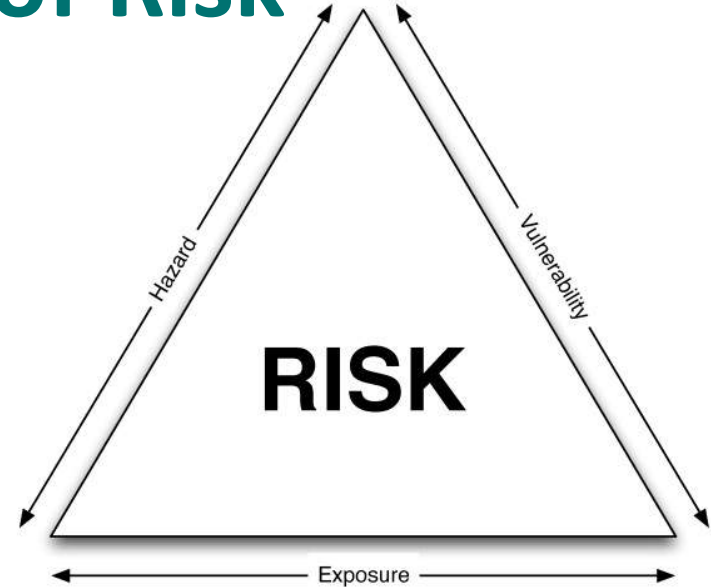
- **Risks** associated with natural hazards can be understood as an interaction of **hazards**, **exposure**, and **vulnerability** forming a 'risk triangle' (Crichton, 1999; 2007).

- Risk associated with some particular hazard lies in the consequences of that hazard, and increases through **probability**, **severity**, and **exposure**.

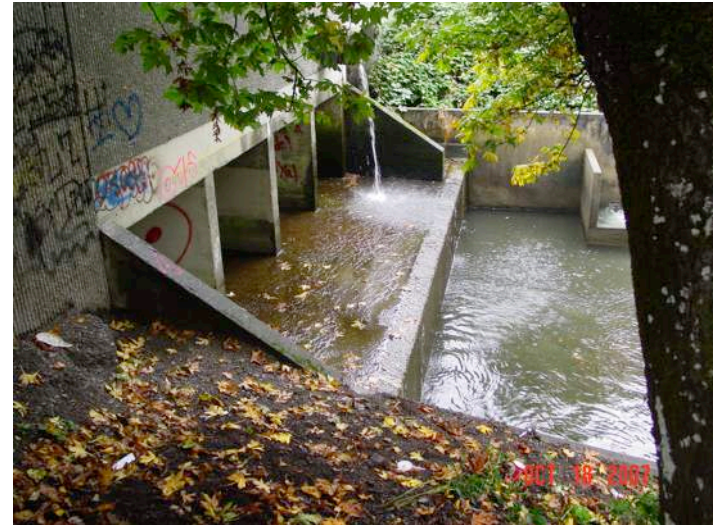
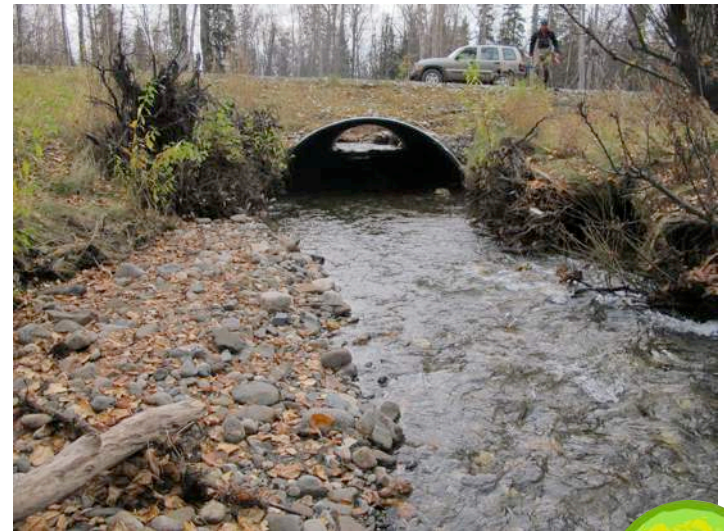
# Culvert

- A ***culvert*** is a control structure that is normally constructed so channel flow can pass under a road.
  - Can act like:
    - Weir, flume, pipe, or channel
- Culverts often cause the flow upstream of structure to rise above normal ***stage***.
  - This phenomenon is called a ***backwater***.

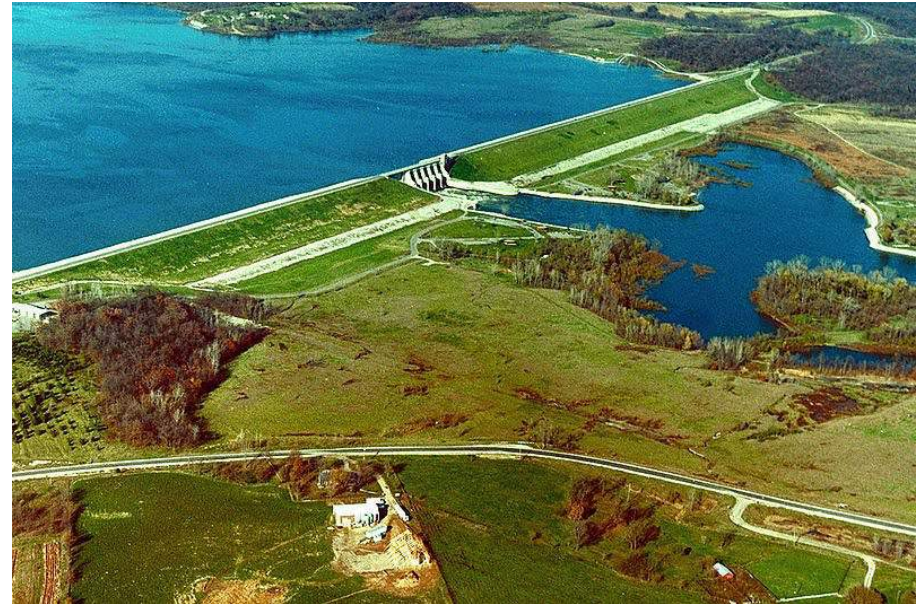
- The “permanent” pool of water that is formed up to the ***principle spillway*** is usually sized based on:
  - Sediment inflow during the life of the impoundments;
  - Recreational needs;
  - Water supply requirements.
